# Thermal Roof Inspection — Example Report

SkyVector Drone Solutions · Waikato, New Zealand · Operating under CAA Part 101

Example Waikato roof + solar array (site redacted)

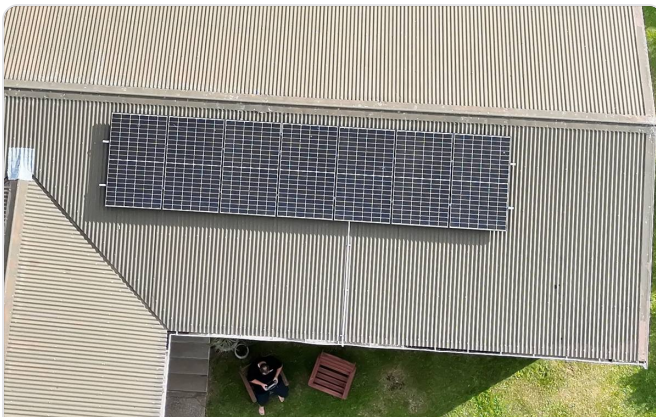
**RGB / visual** context still (example)

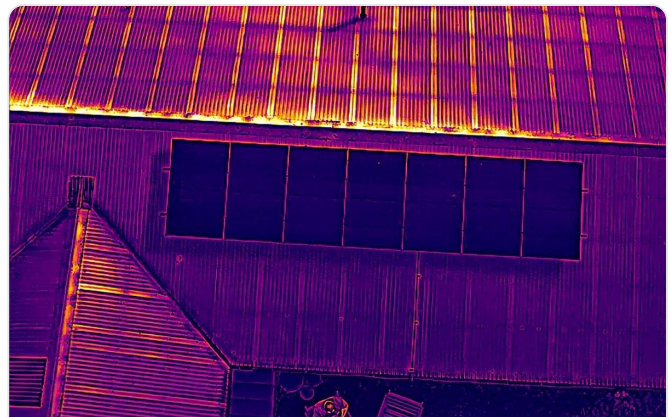
**Thermal** radiometric still (example)

- Warmth along the main ridge — worth checking for insulation gaps or air leakage paths.
- Solar array reads relatively cool and even in this pass — no obvious hot-cell pattern on the visible modules.
- Local heat cues near ridge junctions warrant builder or roofer follow-up; electrician review if panel anomalies appear on a later sunny pass.

- Share these annotated stills with your builder or roofer for on-site follow-up.
- Share the solar stills with your installer if you want a second look under better irradiance.
- This SAMPLE pack is not a structural engineer's certificate or an electrical compliance certificate.
